## Environment Agency visit to Ashton Keynes - 7<sup>th</sup> July 2020

The purpose was to look for obstructions or other issues that could lead to a flooding risk from the river. The stretch of the Thames inspected was from Flood Hatch Copse to Oaklake Bridge ([map-1](#)).

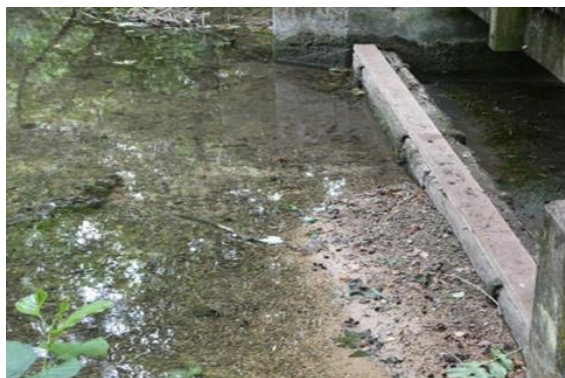
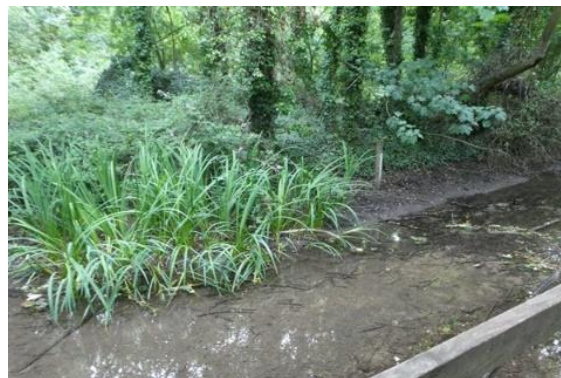
### Flood Hatch Copse

There is a fixed blind crest sluice here which naturally adjusts the river flow, depending on water levels, and will divert some water over the sluice down the overflow channel towards Swill Brook.

During periods of high rainfall, typically in Winter, the sluice acts to divert a significant amount of river flow away from the village southwards towards Swill Brook. Its condition is generally good, and it appears that some 6x4 inch timbers have been added atop the older wooden barriers. One end of a board appears to be starting to rot, with a little water leaking into the overflow channel.

Where large broken branches are in or overhang the river, these should be cleared to avoid debris becoming trapped on them and potentially causing an obstruction. This can happen in the Winter months when reeds and river vegetation die back and are carried away downstream by the river. There were a few such branches noted here.

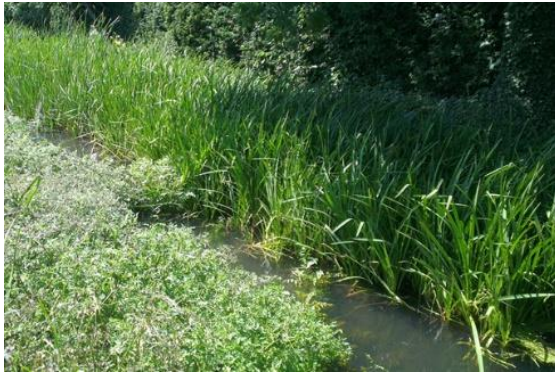
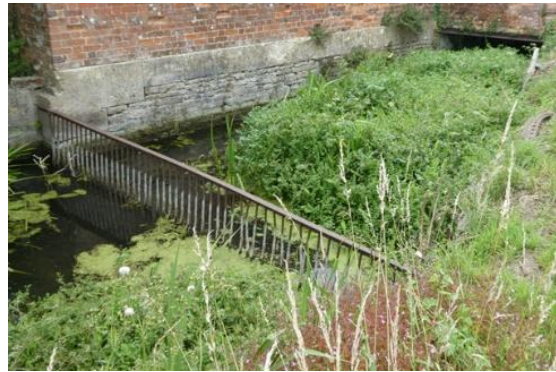
### Approach to Mill House

Where there was no tree canopy shading the river, the reeds had grown to cover nearly all of the river width towards the Mill House debris catch grid. Reeds and river vegetation are not

Reeds and other river vegetation die away in the Winter and are carried downstream, and over this stretch of river will be trapped by the catch grid. It is important that this catch grid should be monitored during Winter months, and kept clear of any build-up of debris.

The river bank at the culvert entrance by Mill House, on the footpath side, appears to be in poor condition and may seep water onto the footpath, or overflow at times of high water levels. Some maintenance work could be carried out here to prevent seepage problems.

A small sluice to the side of the catch grill does not appear to be in use. It is possible that the owner may not want water flowing through the property, and does not control it.

It was recommended that the debris catch grill be removed and replaced with a new custom made catch grill across the culvert entrance, fixed directly to the wall above. This could have a walkway for safe and easy access when debris needs to be removed.

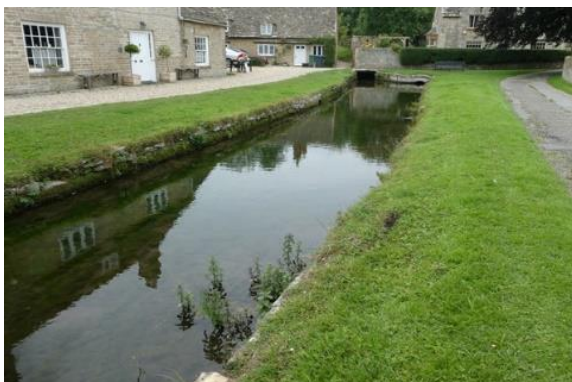
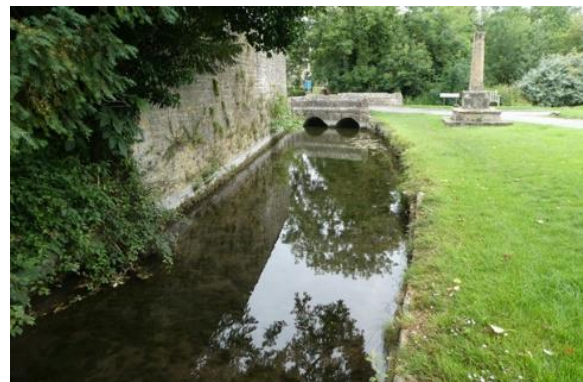
### Church Walk stretch through to the High Road

The stretch of river through Church Walk is in good condition. There are signs of a build-up of algae, weeds, and silt. However, this will be clear with increased water flow later in the year.

Some years ago, the Thames continued down Back Street, via the culvert under the High Road from Church Walk. This offshoot is now dry and with a noticeable build-up of silt and earth.

The Church Walk entrance to this culvert appears to be blocked with river dirt, and this could suggest that the culvert under the road may be blocked. If so, it is thought that responsibility for clearing it lies with Wiltshire Highways, who may if requested inspect it with a camera probe.

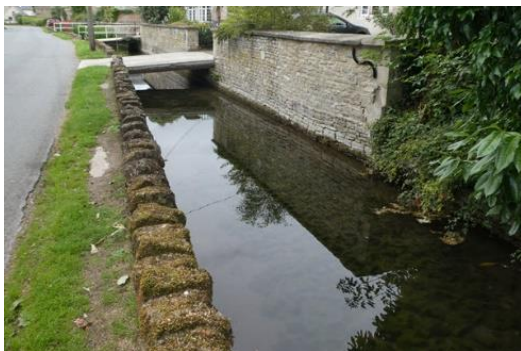
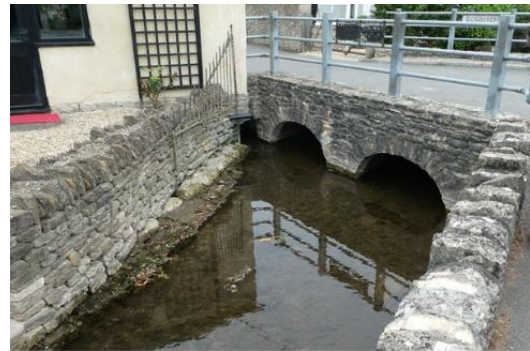
### High Road stretch

The stretch of the Thames along the High Road from Church Walk to the River House sluice was considered to be in good condition, and nothing problematic was identified.

In this stretch the flow of water is not restricted by the width of the channel, or any vegetation in the river. The flow of the river is governed by the available space under the bridges downstream. As most of the bridges have arches, and in some cases where the channel also narrows, this becomes the throttle space through which the water flows.

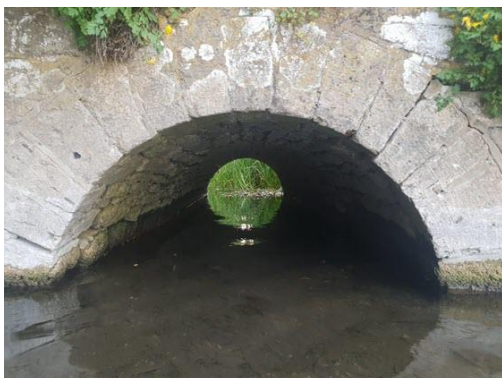
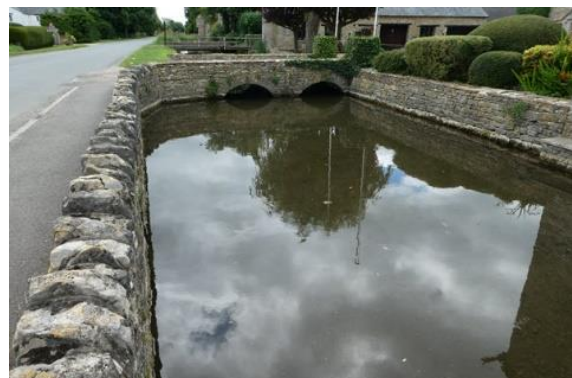
In times when the river level is high, the water may not flow quickly enough under a bridge and the river level will rise. Clearing vegetation from the section of river directly upstream of such a bridge would have no effect on overall flow, and would therefore not impact the river level nor mitigate any flood risk.

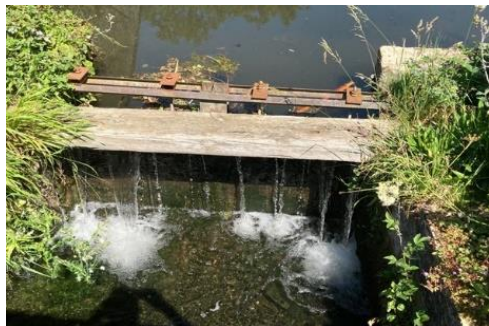
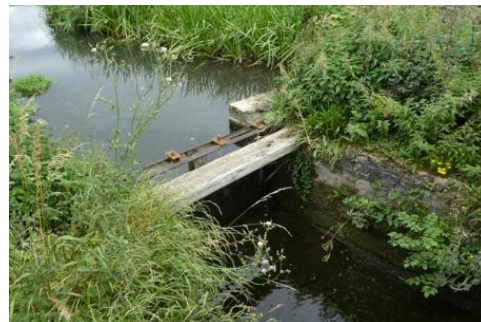
## River House Sluice

The sluice at the River House maintains the water level in the river upstream. It is thought that the sluice was installed here many years ago to divert water up the side channel to service a tannery. Nowadays, the sluice is used to manage river levels: for example kept lowered during Summer to prevent the river drying out, and raised in the Winter to allow free flow of water.

The Environment Agency was satisfied that the Sluice was being operated correctly. They agreed that during Winter months when the river level is high and flowing fast and strong, silt on the riverbed would be moved downstream by the river flow.

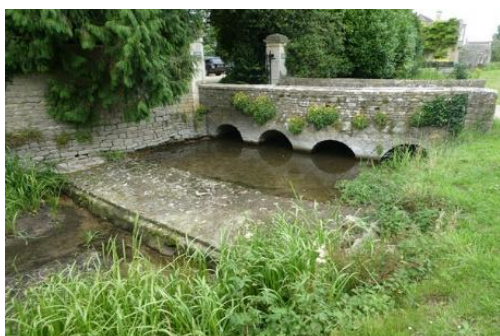
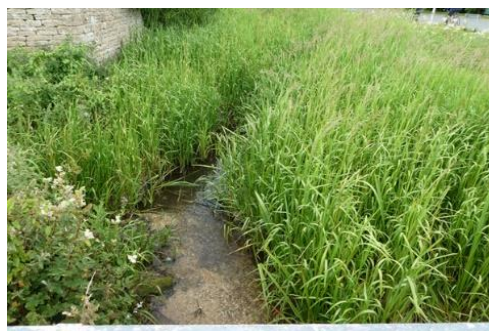
## Approach to the Derry Bridge

The approach to the Derry Bridge from Ashton House has an increasing amount of river vegetation, primarily reeds, towards the bridge, giving the impression that the arches under the Derry Bridge may be blocked. Close inspection reveals this is not the case – indeed all the arches of both Garden House/Ashton House bridge and Derry Bridge are clear. Some removal of reeds to create a wider central channel towards Derry Bridge would be beneficial to flow.

As previously mentioned, the width of the bridge arches are the limiting factor of river flow in times of high river levels. This is especially relevant at Derry Bridge, where the removal of more vegetation upstream of the bridge would not increase the flow capacity under the bridge.

- b. To increase the channel from Garden House to the Derry Bridge, aiming for a clear channel width of 1-1½ metres.
- c. To increase the channel from the Derry Bridge to Oaklake Bridge, aiming for a clear channel width of 1-1½ metres.
- d. To increase the channel from the Swill Brook overflow as it flows into Oaklake Bridge, aiming for a clear channel width of 1-1½.

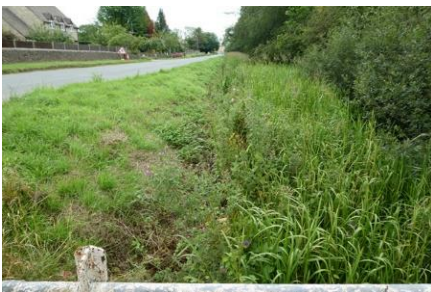
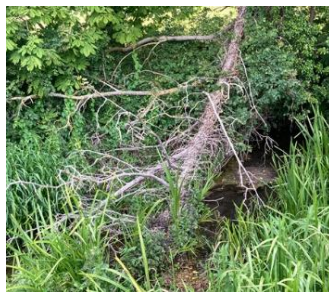
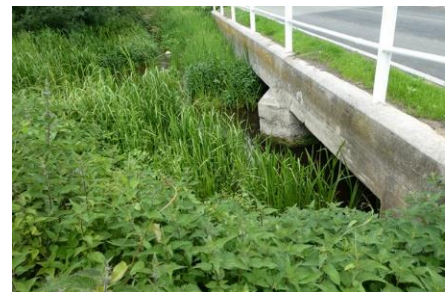
## Approach to Oaklake Bridge

A large dead tree branch was seen lying across, and partly in, the river. This could lead to a large obstruction should debris such get trapped and builds up. It was highly recommended that this should be removed. The riparian owner will need to give their permission for this.

During a visit by the Environment Agency on the 4<sup>th</sup> December 2019 it was observed that the river level at Oaklake Bridge was at the sill level of the bridge. This means that no more water could flow out of the village, regardless of the levels of vegetation directly upstream.

The bridge sill height above the water level, and the width of the channel, under Oaklake Bridge are the governing factors for water flow out of the village.

Clearing the river vegetation upstream of the bridge will not increase the flow capacity under the bridge, and so will not mitigate a high river level, nor any flood risk. However, limited removal of some vegetation to widen the channel will aid water flow in normal times.

- a. Remove a fallen tree branch overhanging the river south of the Derry Bridge.
