## Environment Agency visit to Ashton Keynes - 7<sup>th</sup> July 2020

The purpose was to look for obstructions or other issues that could lead to a flooding risk from the river. The stretch of the Thames inspected was from Flood Hatch Copse to Oaklake Bridge ([map-1](#)).

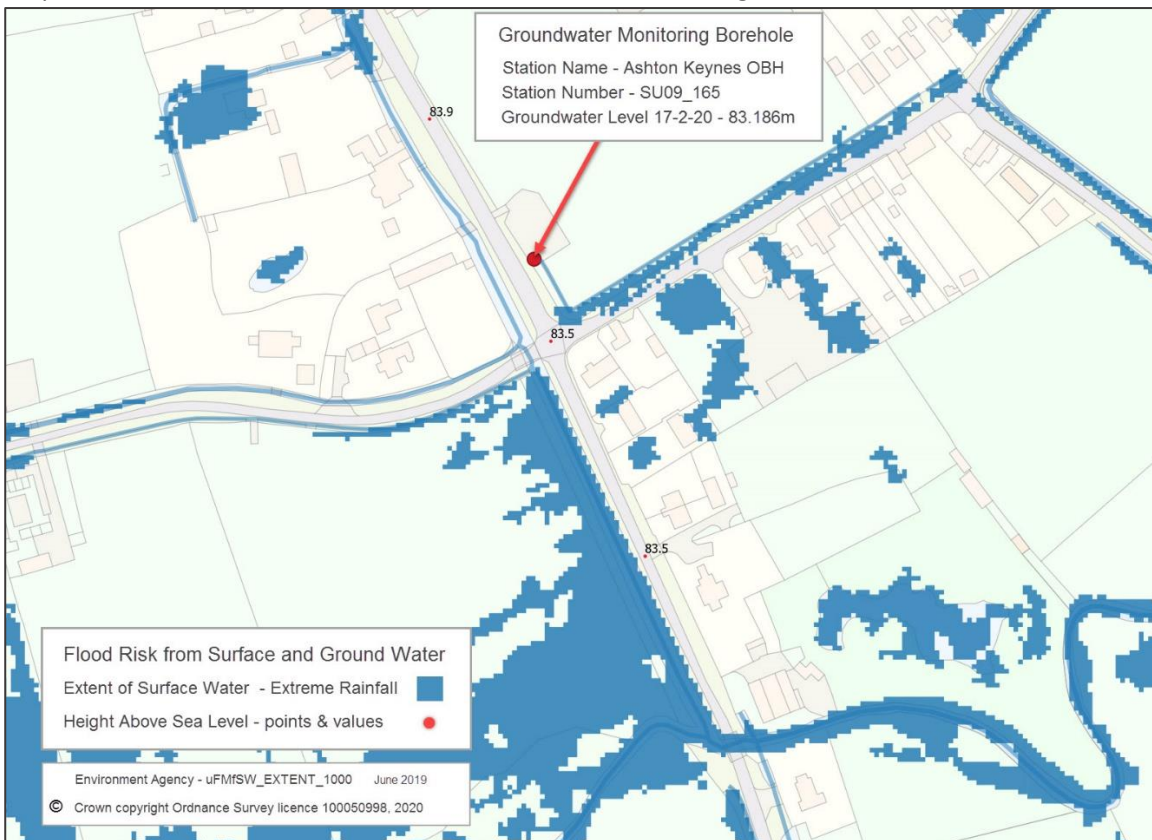
Map-2 - the effect of Surface Water and Groundwater flooding in Winter 2020:

The prediction for surface water flooding in the fields and gardens adjacent to the High Road south of The Derry and Happy Land in extreme rainfall conditions was agreed to be in accordance with the flood risk map produced by the Working Group ([map-2](#)), which used surface water flood prediction data and groundwater data from the Environment Agency. It was also confirmed that land south of the Derry was designated as a flood plain.
